Manhole Inspection Summary

Manhole # S17M__039MH

Insp Date: **4/16/08 10:04 AM**

Location Address: **2501 frederick av** Cross Street: **franklintown rd**

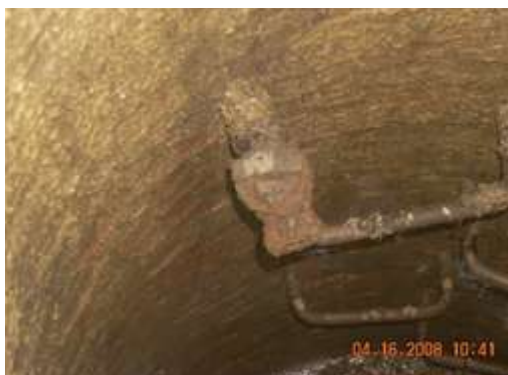
misc. pipe intruding through corbel wall @ 9 o'clock

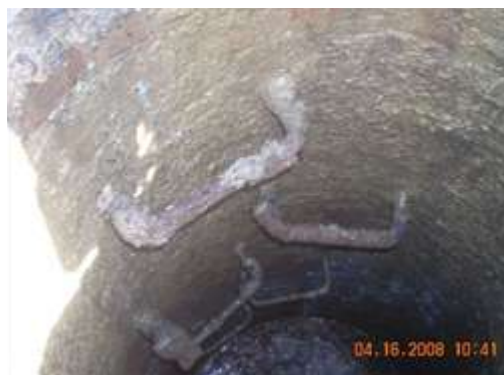
Defect 6

Steps Count: **6** Missing: **0** ☒ **Corroded**

@ 9 o'clock

corroded steps

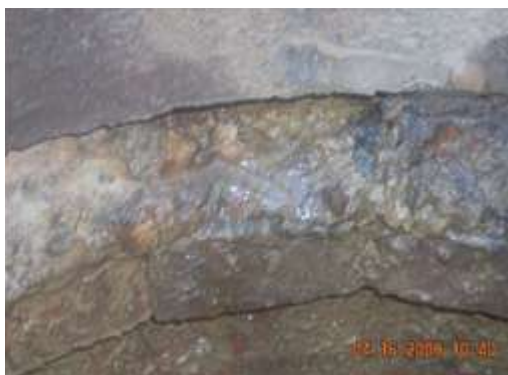
Defect 5

Condition: ☐ Sound ☐ Cracked ☐ Root Intrusion ☐ Loose Brick ☒ **Deteriorated**

deteriorated chimney

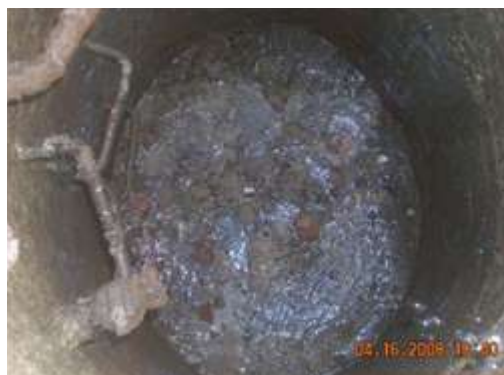
Defect 4

Condition: ☐ Sound ☐ Cracked ☐ Root Intrusion ☐ Deteriorated ☐ Leaks ☒ **Debris**

Surcharge ☒ **Evidence Of Surcharge** Depth: **1** (ft.) ☒ **Active Surcharge Present**

debris/mud in terminal channel, active surcharge

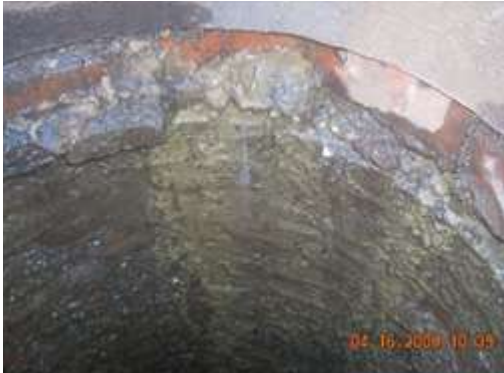
Defect 3

Infiltration: ☐ None ☒ **Joint** ☒ **Cracks** ☒ **Mortar** ☐ Roots ☒ **Wall**

infiltration dripper @ chimney joint,
through cracks and mortar

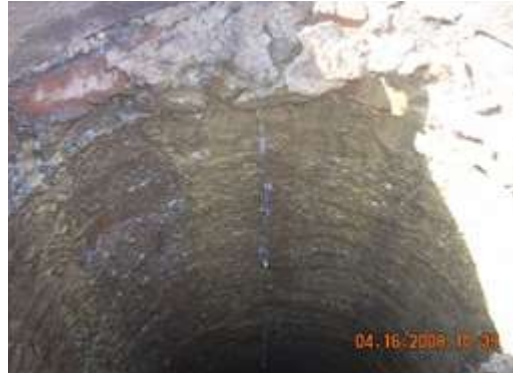
Defect 2

infiltration runner @ chimney joint,
infiltration through mortar and wall

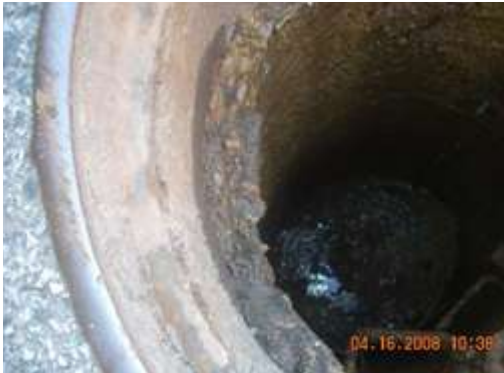
Defect 1

Frame Offset: **1** (in.) Condition: ☒ Sound ☐ Cracked ☐ Leaks

frame offset

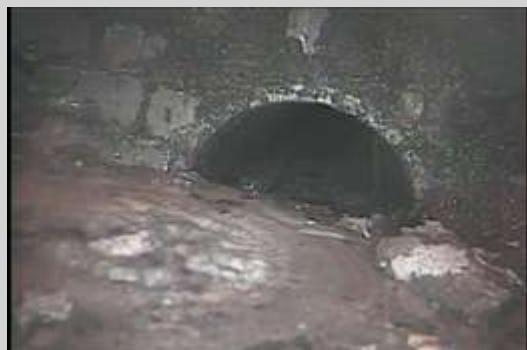
12 O'Clock Outflow

8 in. Circular Gravity Sewer
Pipe Out @ 12 O'Clock

Deposits: ☐ None ☒ **Mud** ☐ Sludge ☐ Debris ☐ Grease

Silt Depth: **3** (in.) Deposits Extent: **Medium**
